REPORT OF MARINE SURVEY

CONDITION & VALUATION

■■■■■ MERIDIAN 341 SEDAN

Cale Mathers – ■■■■■
SAMS® Accredited Marine Surveyor®

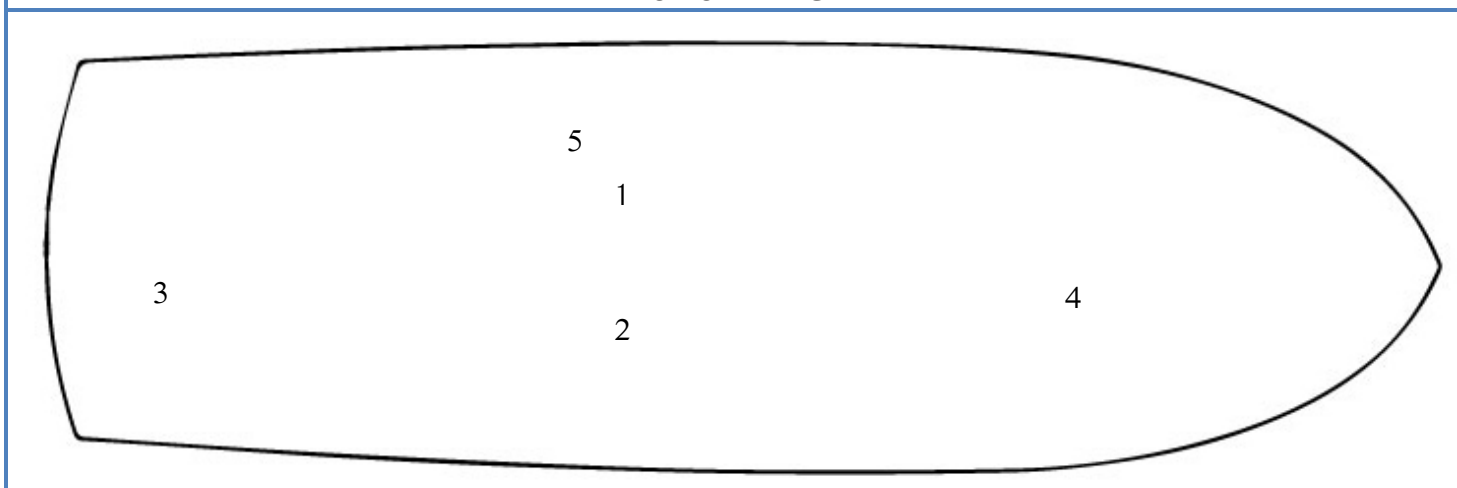
THRU-HULL DIAGRAM

THRU-HULL DESCRIPTION		CONDITION
1	PORT Engine Seawater Intake	FUNCTIONAL / AVERAGE / Valve is Stiff / Exercise to Ensure Reliability
2	STBD Engine Seawater Intake	FUNCTIONAL / AVERAGE / Valve is Stiff / Exercise to Ensure Reliability
3	Generator Engine Seawater Intake	FUNCTIONAL / AVERAGE / Valve is Stiff / Exercise to Ensure Reliability
4	Washdown Pump Seawater Intake	FUNCTIONAL / AVERAGE / Valve is Stiff / Exercise to Ensure Reliability
5	Black Water Pump Discharge Overboard	FUNCTIONAL / AVERAGE / Valve is Stiff / Exercise to Ensure Reliability

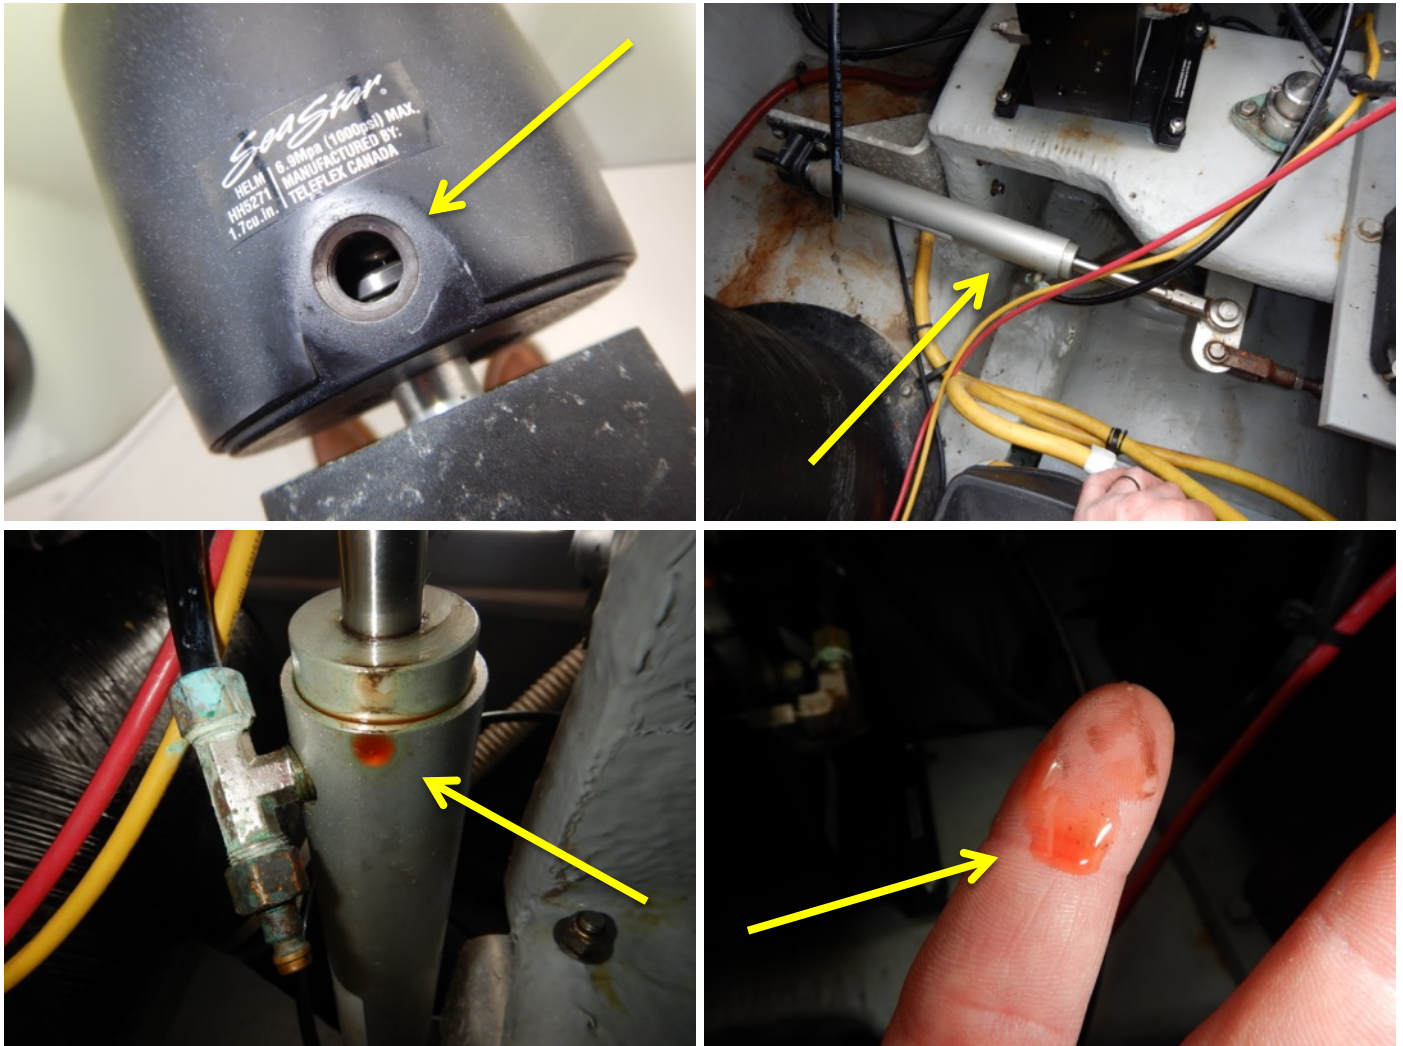
2. Hydraulic Steering System

The hydraulic steering system performed in BELOW AVERAGE condition. The steering was FUNCTIONAL & felt normal when operated at the pilothouse control station, but the flybridge station steering wheel had an abnormal feel consistent with air being trapped in the hydraulic system (excessive amount of wheel turns to change rudder position). There was evidence of a hydraulic oil leak identified at the steering cylinder installed on the STBD side of the lazarette bilge compartment. Recommend adjust, repair, or replace defective hydraulic steering system components as needed with the intent to eliminate oil leaks & improve operating performance. Consult a qualified technician or reputable service facility to discuss troubleshooting & service options. Clean & dry bilge compartment surfaces, place absorbent pads in strategic locations, monitor on a regular basis for recurring deficiency, and perform appropriate maintenance service in a timely manner if active fluid leaks are discovered.

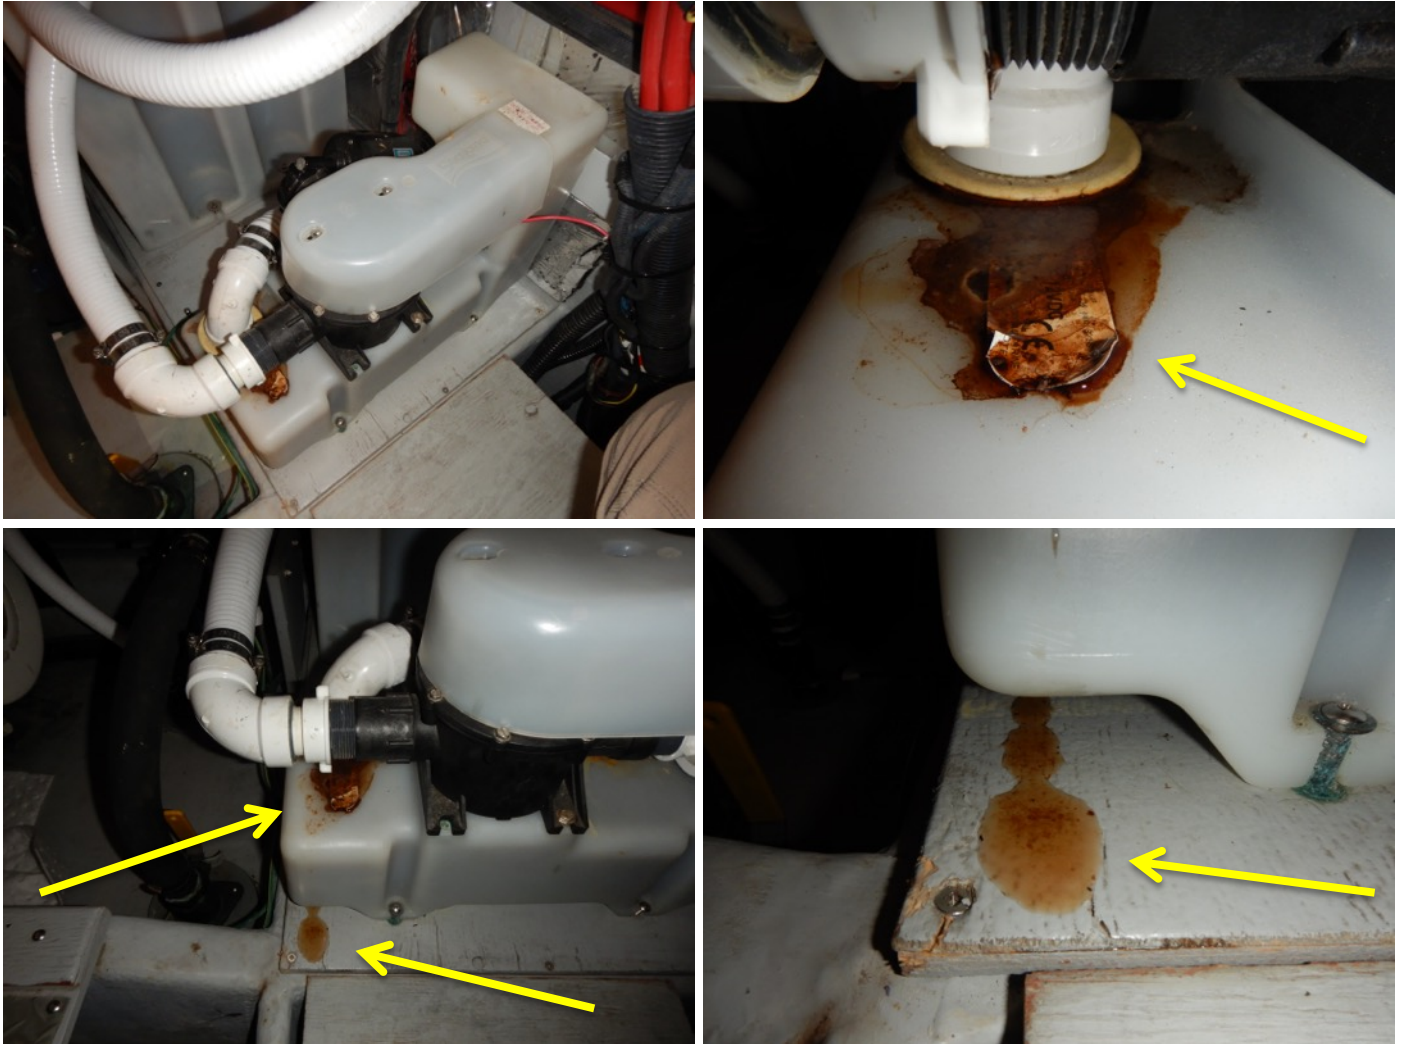
3. Black Water Fluid Leak

There was evidence of a black water fluid leak identified at in the engine room bilge compartment. The leak appeared to originate at the vacuum generator pump component of the VacuFlush toilet system. Recommend adjust, repair, or replace defective black water sanitation system components as needed with the intent to eliminate fluid leaks. Clean & dry bilge compartment surfaces, place absorbent pads in strategic locations, monitor on a regular basis for recurring deficiency, and perform appropriate maintenance service in a timely manner if active fluid leaks are discovered.

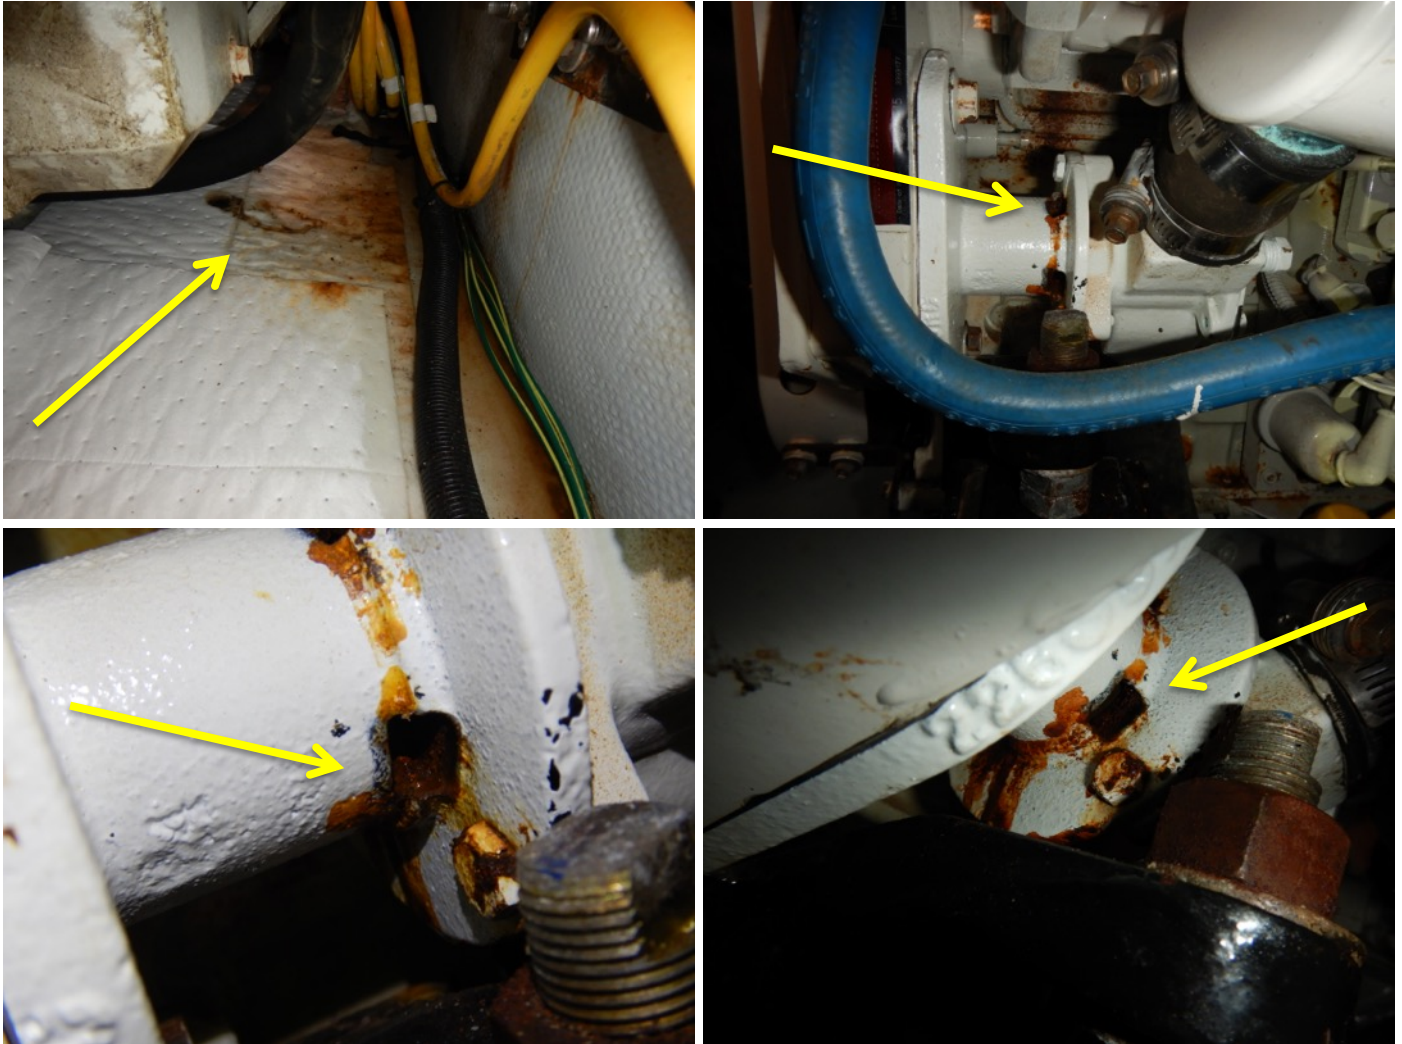
4. STBD Engine Seawater Circulation Pump

There was evidence of a water leak identified at the weep-hole portion of the STBD engine's seawater circulation pump. The condition described is usually an indication that an internal pump seal is beginning to fail. Recommend overhaul or replace the STBD engine seawater circulation pump as an act of preventative maintenance & with the intent to eliminate water leaks.

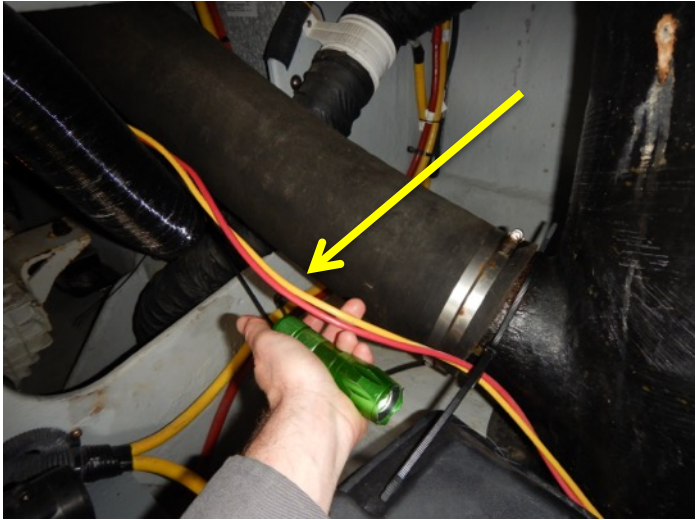
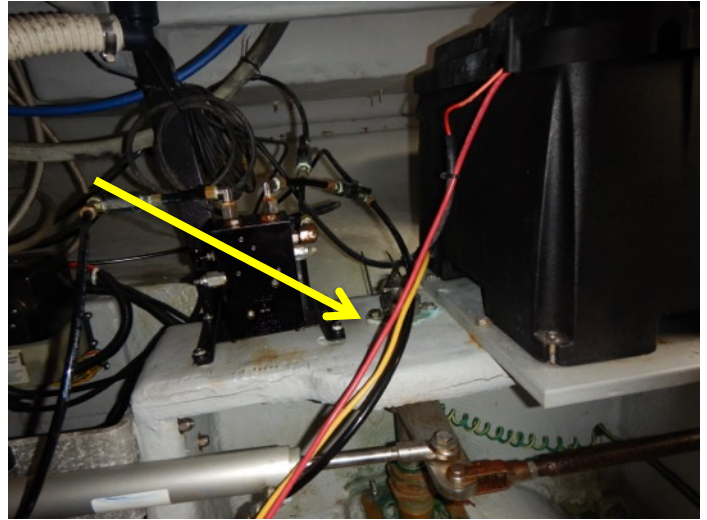
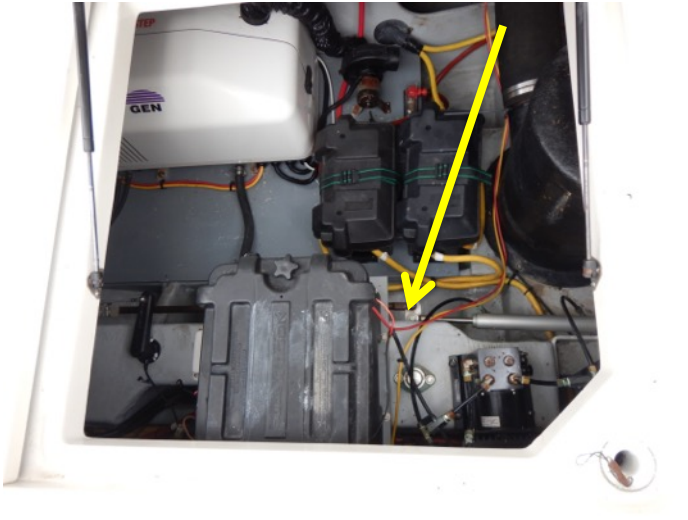
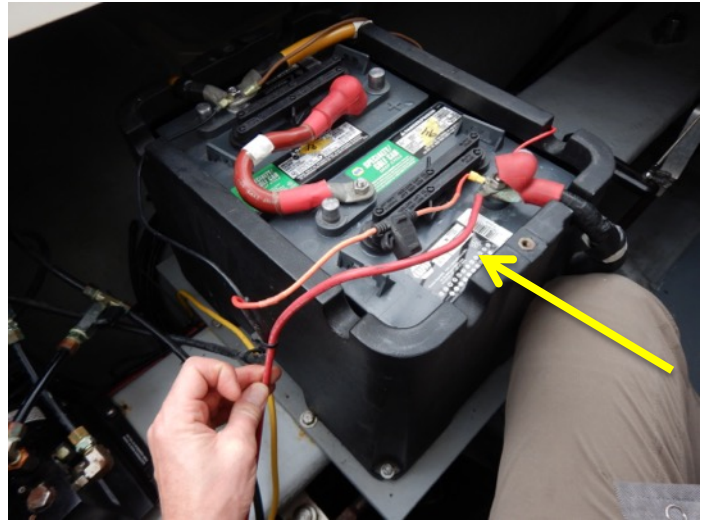
5. DC Overcurrent Protection & Power Conductor Installation

The installation of the POWER INVERTER appliance did not comply with ABYC recommendations. The ungrounded (positive) power conductor was not equipped with overcurrent protection (fuse or circuit breaker), and the power conductors were not adequately secured along the length of the wire run. ABYC recommends: *Ungrounded conductors shall be provided with overcurrent protection device(s) within a distance of seven inches of the point at which the conductor is connected to the source of power measured along the conductor (ABYC E-11.10.1.1.1). Conductors shall be supported throughout their length or shall be secured at least every 18 inches (ABYC E-11.15.4.1.9).* Recommend appropriately sized overcurrent protection be installed at the DC power supply to the power inverter appliance, and ensure that the power conductors are properly secured & protected throughout the entire wire run.

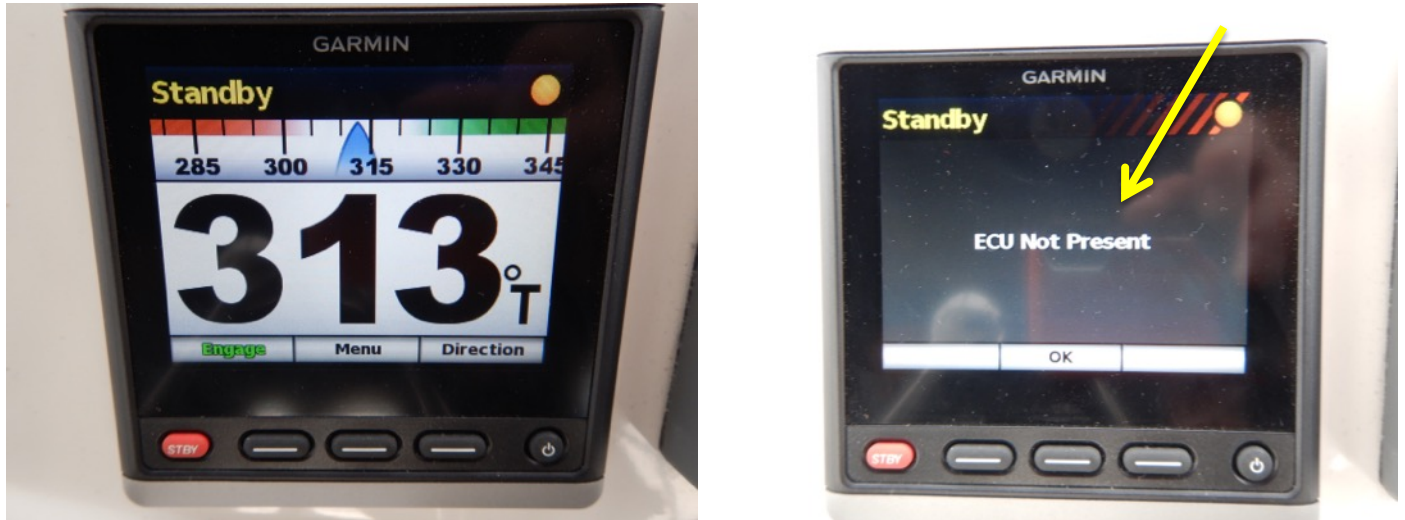
6. Autopilot Steering System

The GARMIN AUTOPILOT system was INOPERABLE. The autopilot electronics did power on, but an error message reading ECU NOT PRESENT flashed on the screen during sea trial testing procedures each time the operator attempted to engage the AUTO function. Further investigation is needed to determine an explanation for the deficiency described. Recommend adjust, repair, or replace defective autopilot steering system components as needed with the intent to improve operating performance. Consult a qualified technician or reputable service facility to discuss troubleshooting & service options.

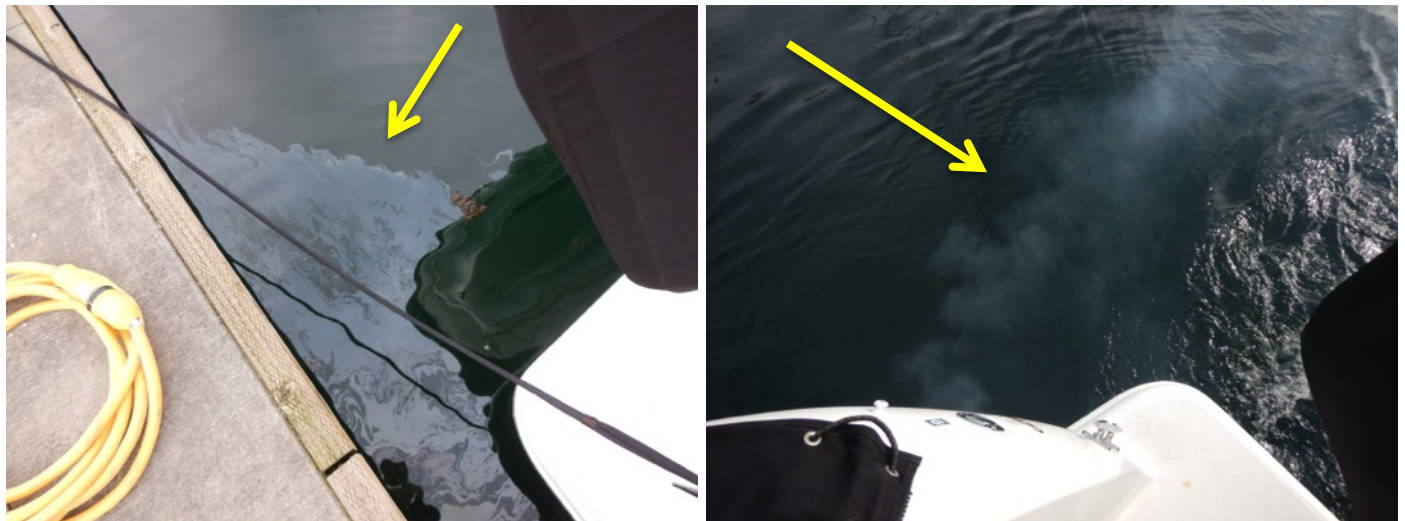
7. STBD Engine Exhaust Smoke & Fuel Sheen

STBD engine operating performance appeared slightly abnormal when observed during sea trial testing procedures. Exhaust smoke & fuel sheen appeared to be excessive. The conditions described may be an indication that the engine is in need of a valve adjustment or fuel injector service. Recommend appropriate STBD engine maintenance service be performed with the intent to improve operating performance. Consult a qualified technician or reputable service facility to discuss troubleshooting & service options.

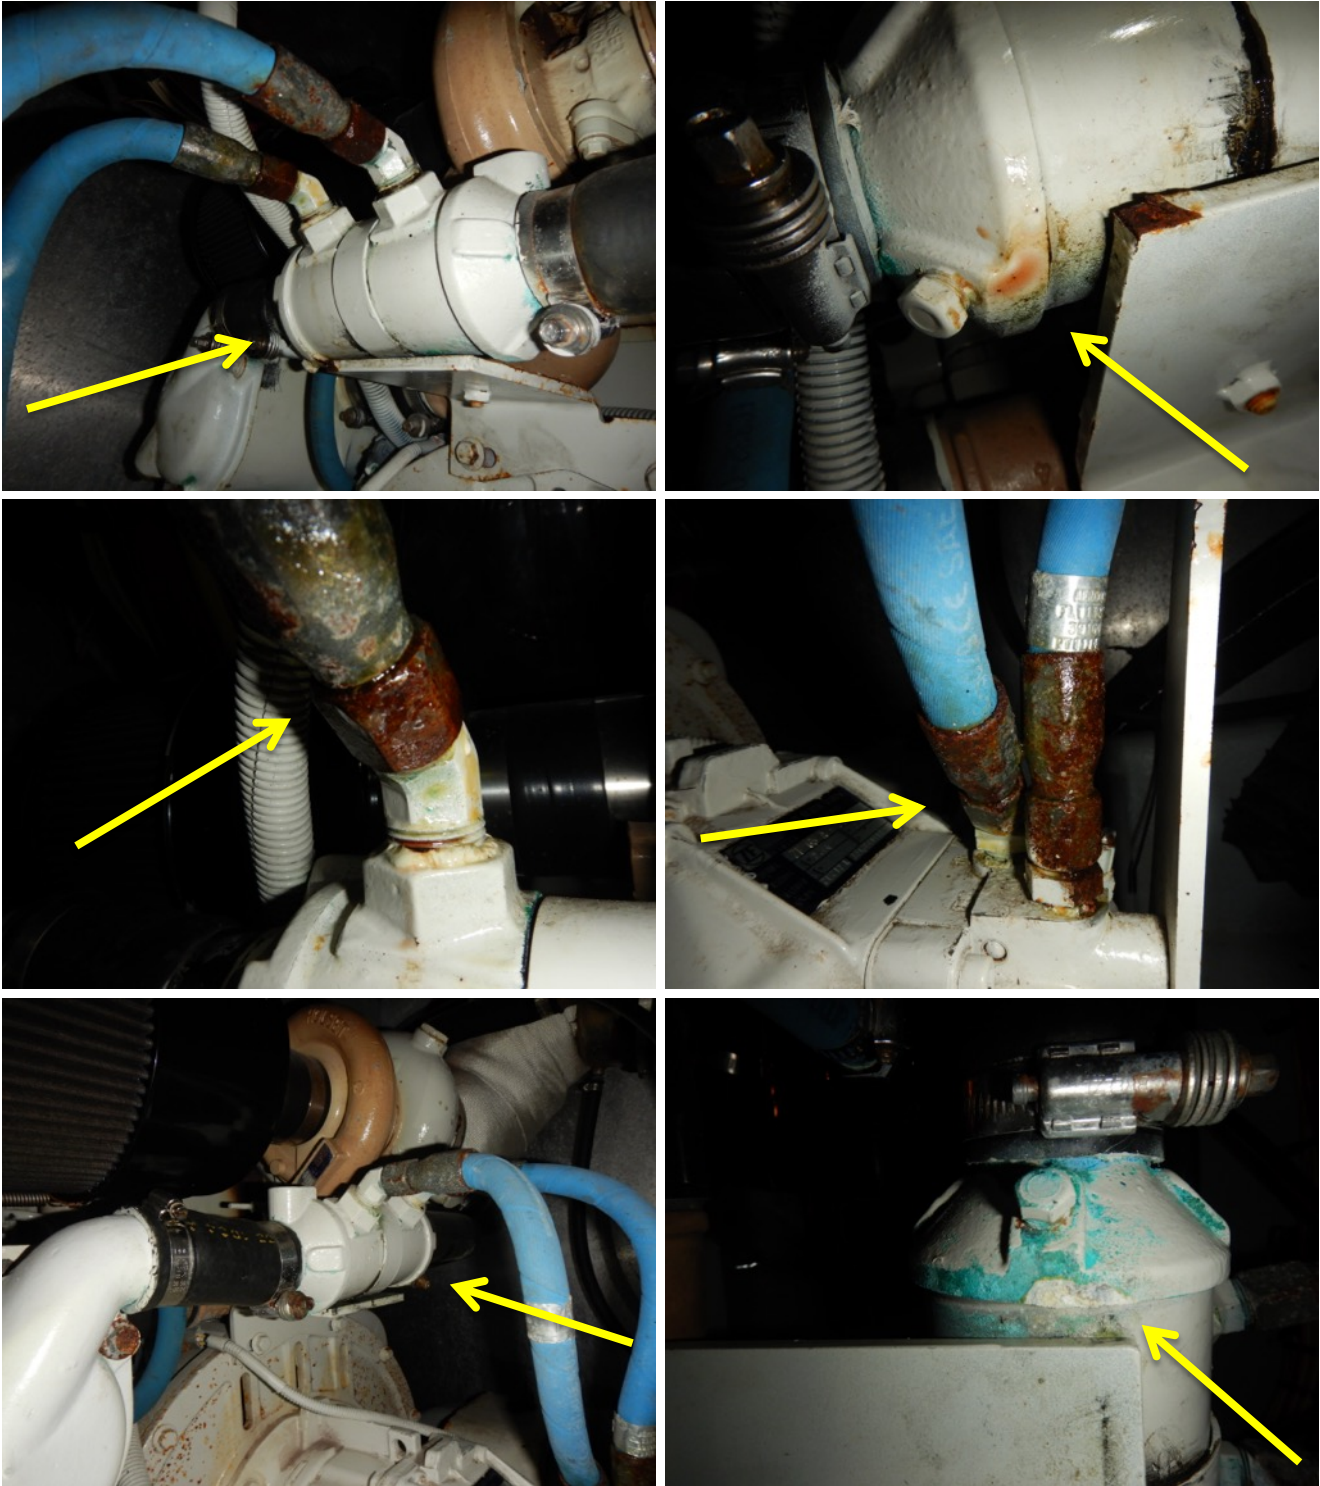
8. PORT & STBD Engine Transmission Oil Cooler

The transmission oil coolers appeared in BELOW AVERAGE condition. There was evidence of oil leaks identified at the location where oil hoses were connected to the cooler assemblies, and there was evidence of corrosion damage identified along the soldered end-cap, which is usually an indication that the cooler is nearing the end of its useful service life. Recommend the PORT & STBD engine transmission oil coolers be replaced as an act of preventative maintenance.

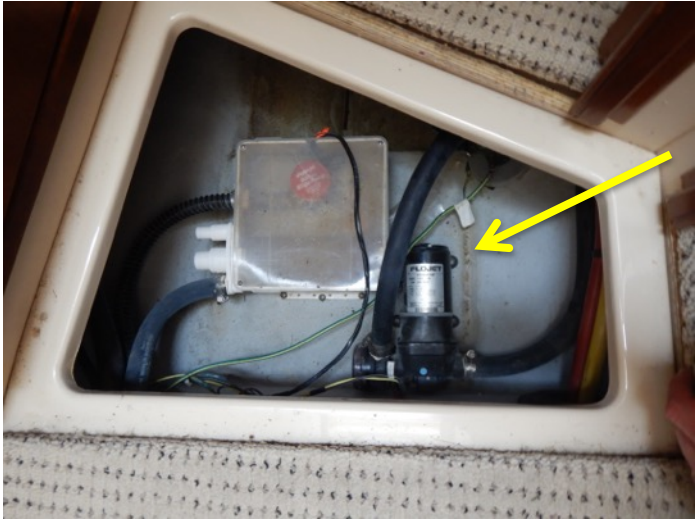
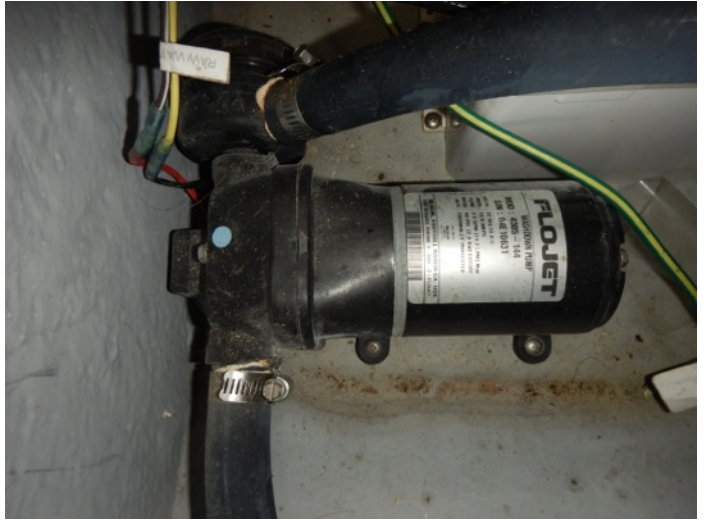
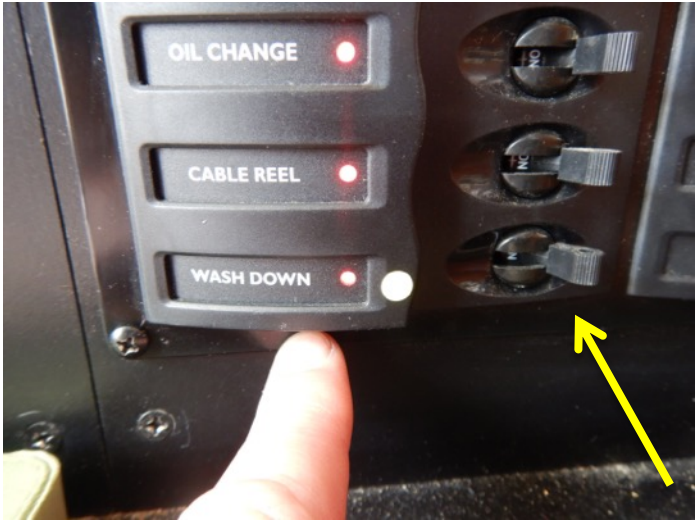
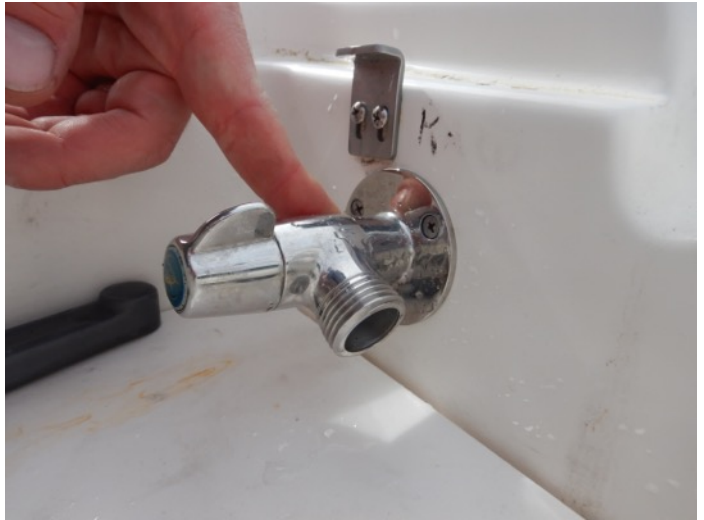
9. Seawater Deck Washdown Pump

The electric water pressure pump serving the seawater deck washdown system was INOPERABLE. The pump described would not power on during testing procedures. Further investigation is needed to determine an explanation for the deficiency described. Recommend adjust, repair, or replace defective seawater deck washdown system components as needed with the intent to improve operating performance.

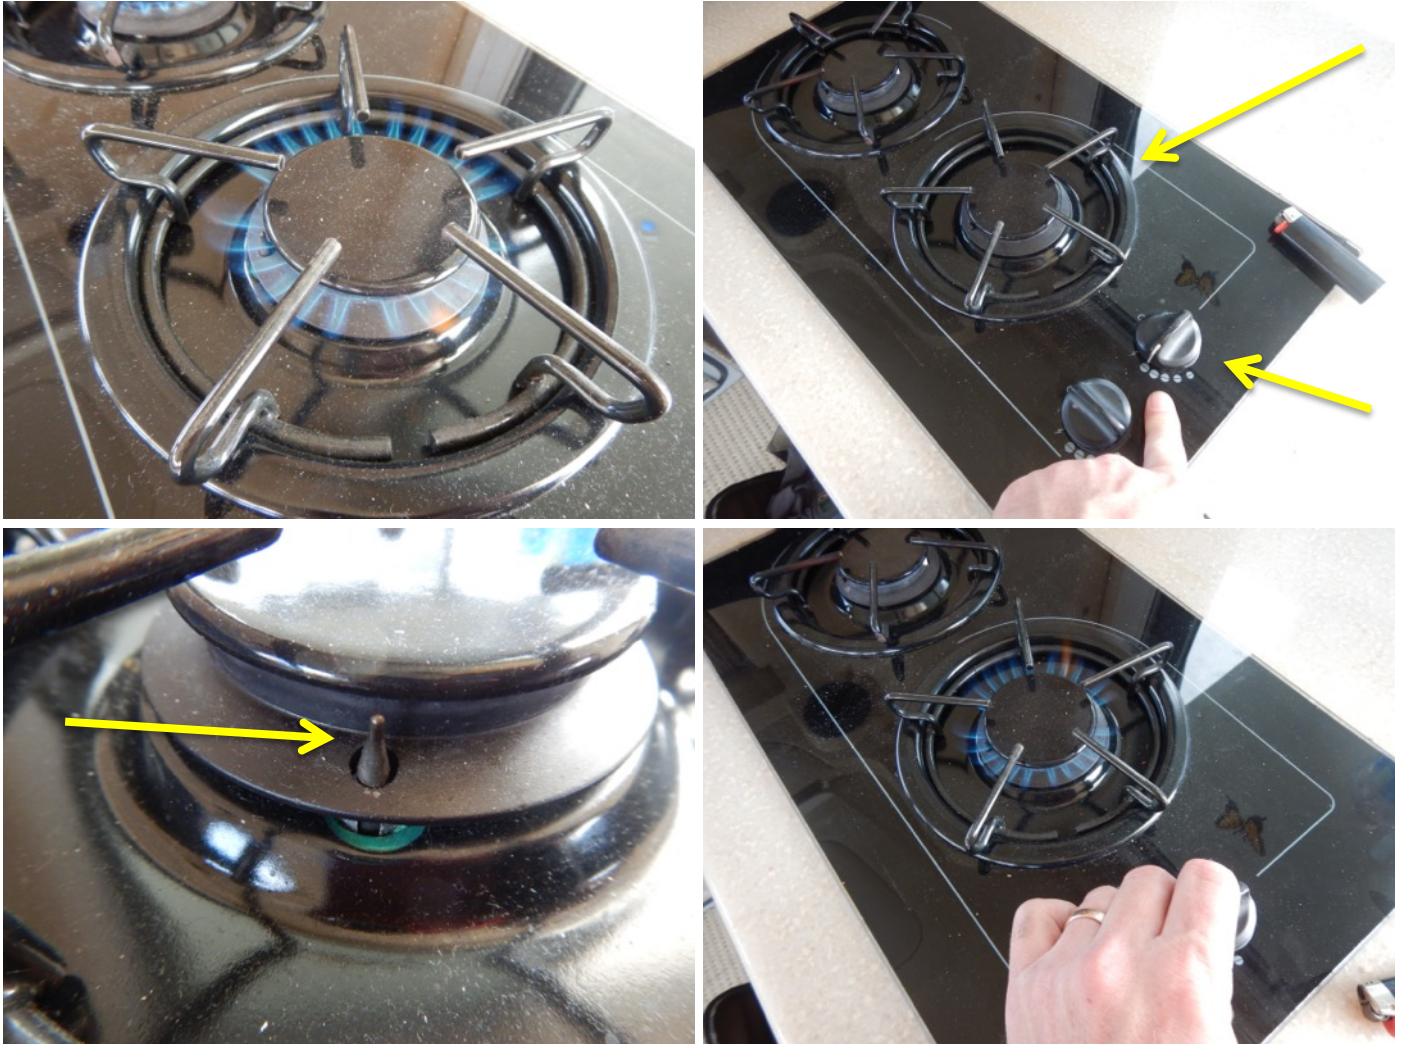
10. LPG Stovetop Appliance

The LPG powered galley stovetop appliance was DEFECTIVE. The STBD burner operated in a NORMAL condition during testing procedures, but the PORT burner was INOPERABLE. The burner would ignite, but the flame would extinguish each time the control knob was let up after the starting procedure was completed. The thermocouple device appeared to be defective. Recommend adjust, repair, or replace defective LPG stovetop appliance components as needed with the intent to improve operating performance.

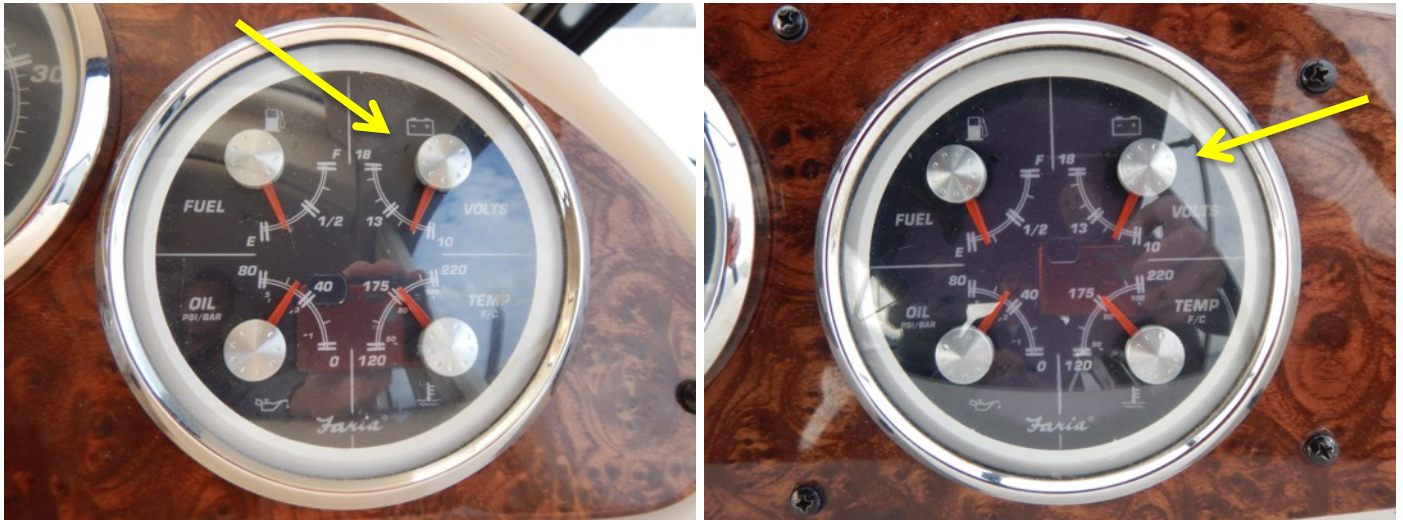
11. STBD Engine Alternator / Voltmeter Gauge

The STBD engine alternator or the STBD engine voltmeter gauges did not appear to be operating properly. The voltmeter gauges indicated <12VDC when observed during sea trial testing procedures. Further investigation is needed to determine an explanation for the deficiency described. Recommend adjust, repair, or replace defective STBD engine alternator or voltmeter gauge system components as needed with the intent to improve operating performance. Consult a qualified technician or reputable service facility to discuss troubleshooting & service options.

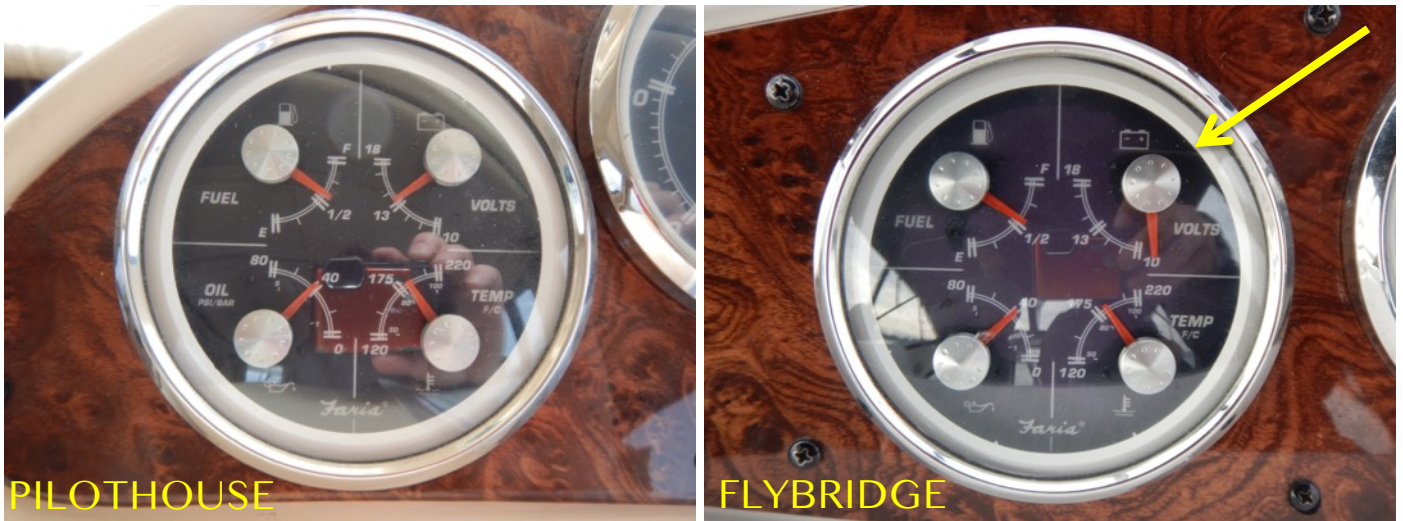
12. PORT Flybridge Voltmeter Gauge

The PORT engine voltmeter gauge installed at the FLYBRIDGE pilot station was INOPERABLE. The gauge was pegged in the MAX LOW position when observed during sea trial testing procedures. The voltmeter gauge installed at the pilothouse control station appeared to operate normally. Recommend adjust, repair, or replace defective PORT engine voltmeter gauge component as needed with the intent to improve flybridge pilot station operating performance.

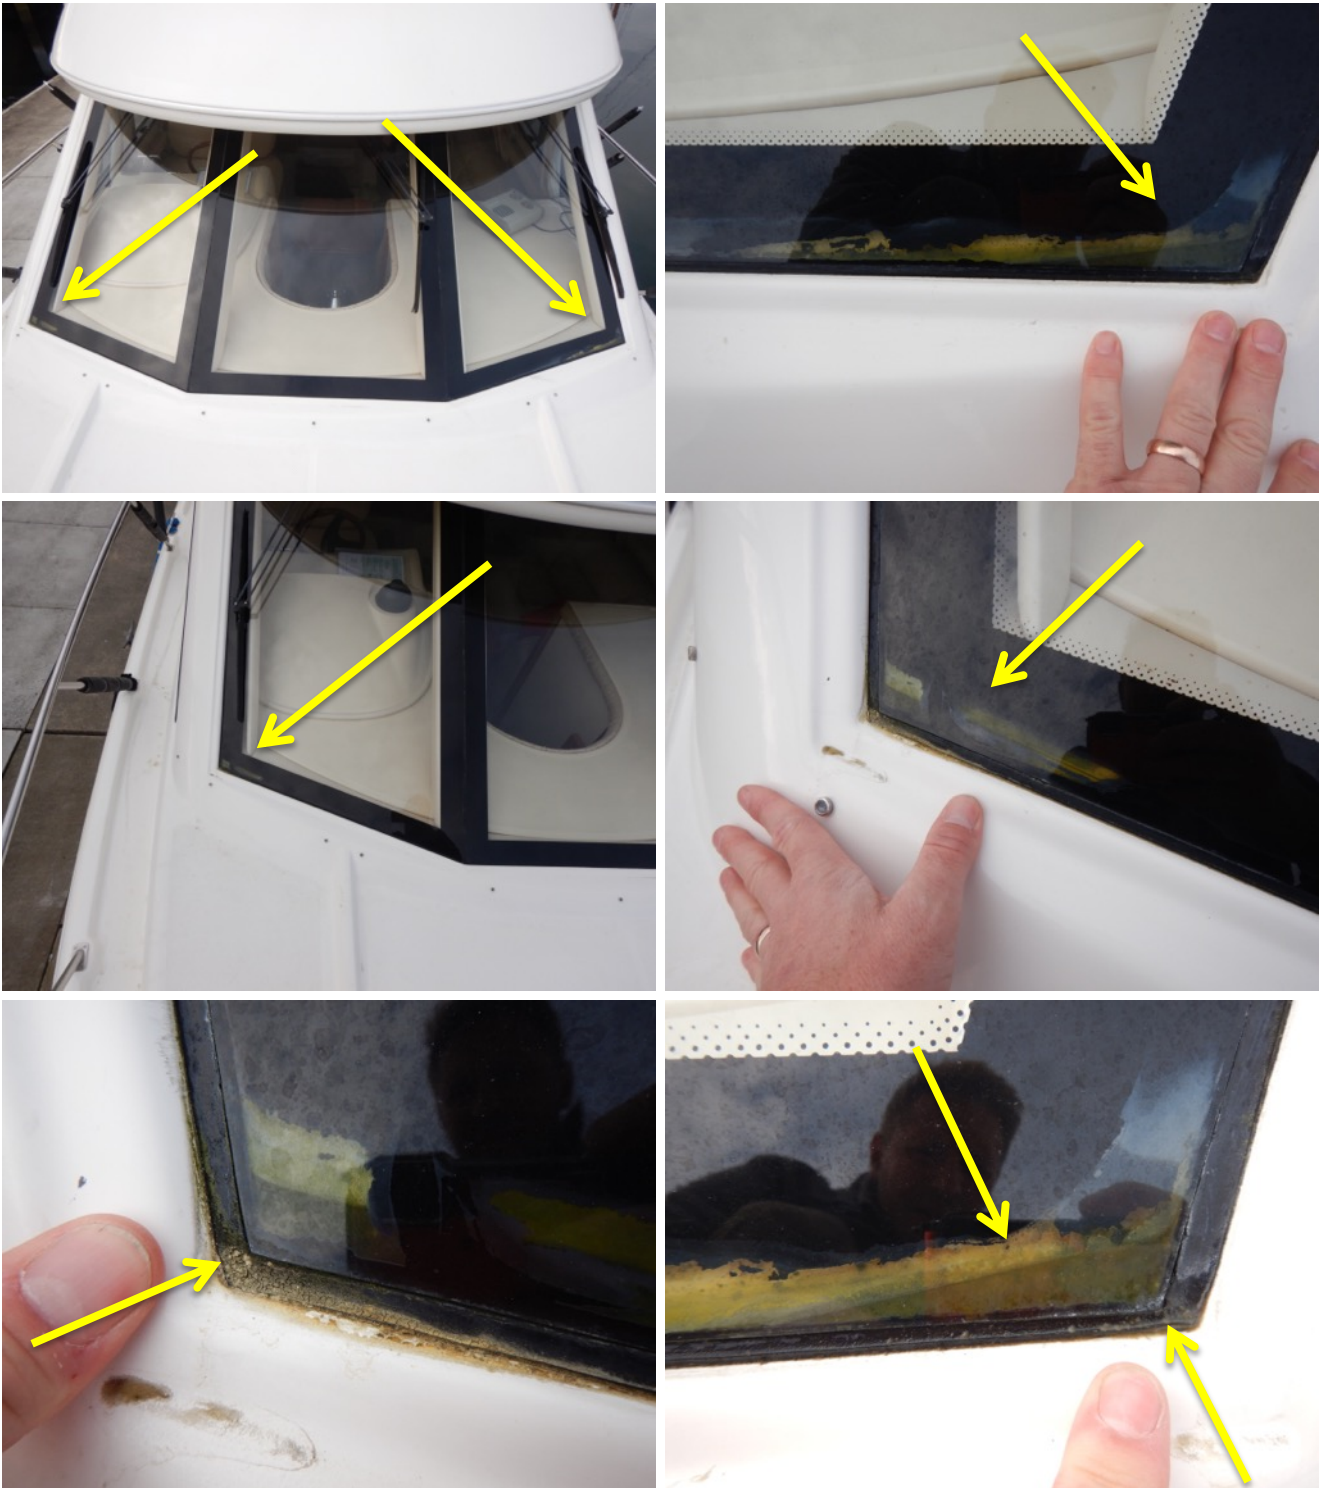
13. Pilothouse Windshield

There was evidence of defects identified at the PORT & STBD corners of the pilothouse windshield. There appeared to be water trapped in a void underneath the window glass. The severity of the window sealant failure was undetermined. Recommend appropriate maintenance service be performed with the intent to eliminate or reduce the severity of windshield water leaks. Consult a qualified technician or reputable service facility to discuss troubleshooting & service options.

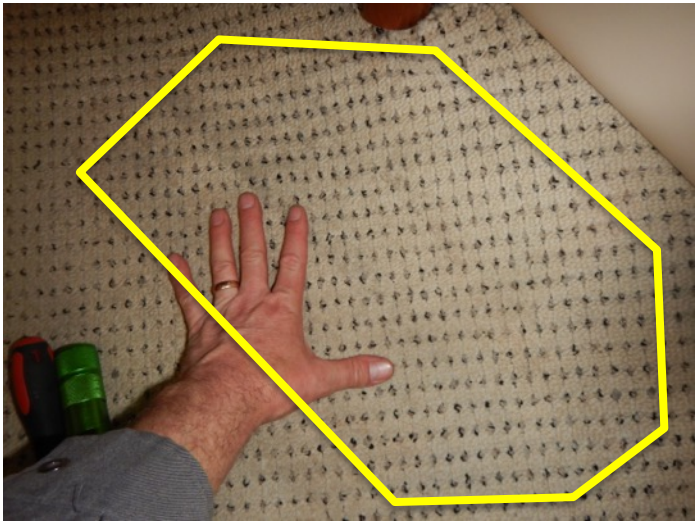
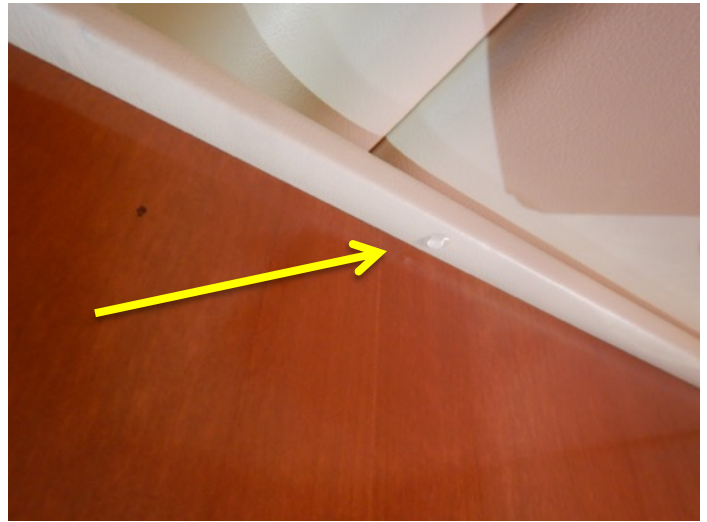
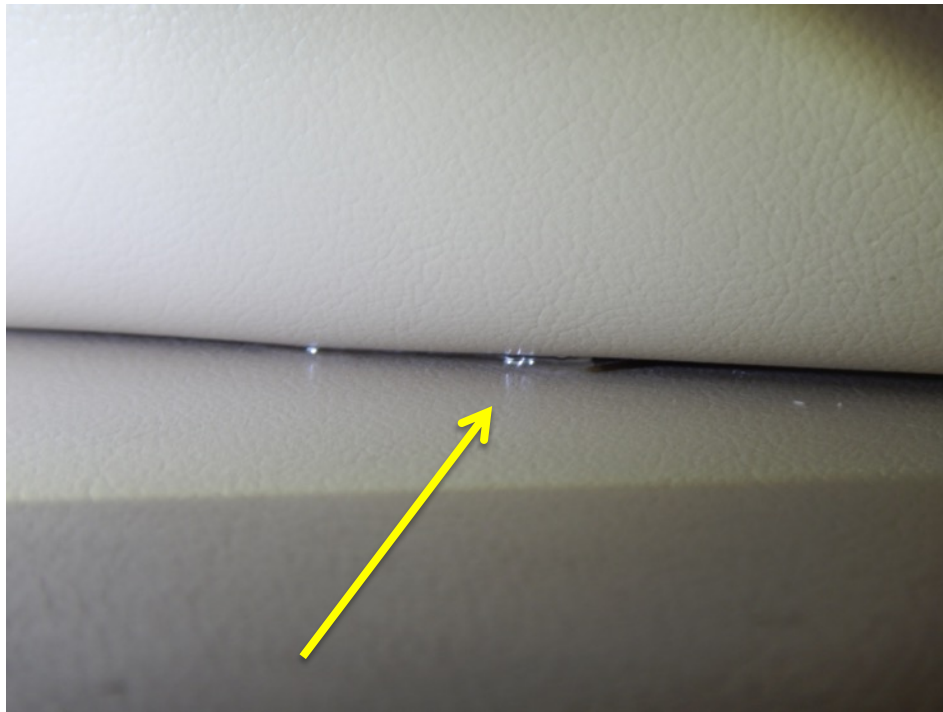
14. STBD Guest Stateroom Water Leak

There was evidence of a water leak identified inside the STBD guest cabin. The floor area adjacent to the closet was wet, and water appeared to be leaking from the ceiling. The water leak may have originated at the STBD side of the windshield, but the initial investigation was inconclusive. Recommend the source of the water leak be located & appropriate repair service be performed with the intent to eliminate fluid leaks.

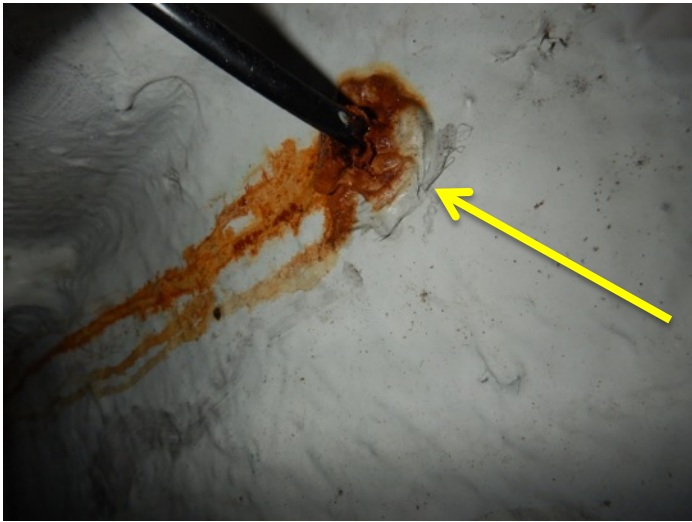
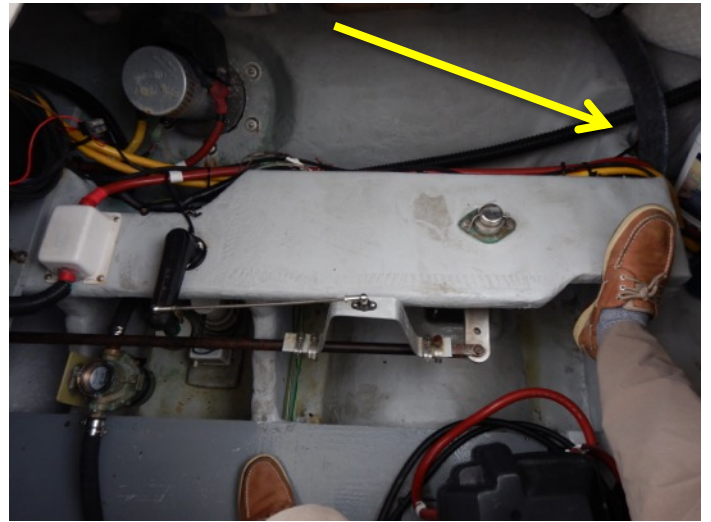
15. Transom Water Leak

There was evidence of a mild water leak identified in the lazarette bilge compartment. The leak appeared to originate at the hole in the transom structure housing the hydraulic hose for the PORT side trim tab. Orange water leak stain markings are usually an indication that fasteners are suffering from the effects of crevice corrosion. Recommend monitor the condition of the water leak defect described, and perform appropriate repair during the vessel's next out-of-water service if condition remains stable, or perform repairs in a timely manner if condition worsens. The trim tab cylinder will most likely need to be disassembled & reinstalled. Consult a qualified technician or reputable service facility to discuss troubleshooting & service options.

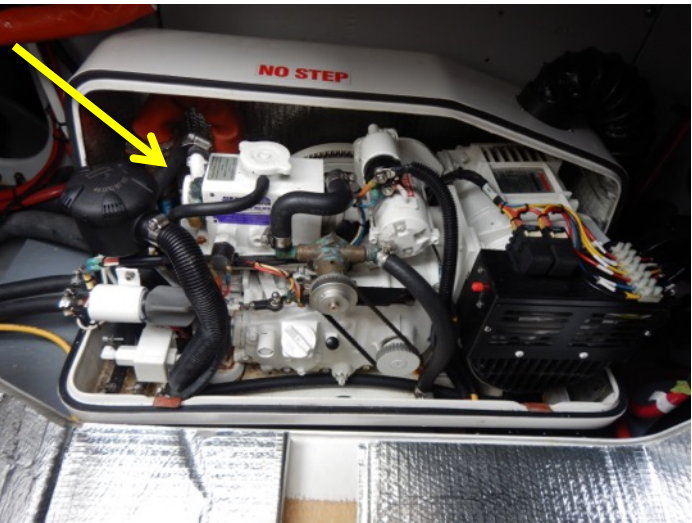
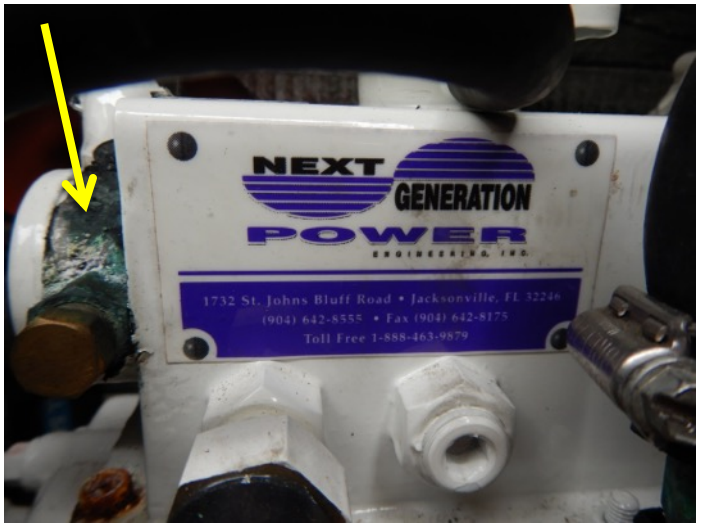
16. Generator Engine Heat Exchanger

The generator engine's heat exchanger appeared in BELOW AVERAGE condition. There was evidence of corrosion damage & a possible water leak identified at the soldered end-cap portion of the heat exchanger assembly. The severity of the defect described was undetermined. Recommend clean & dry the generator engine & sound shield enclosure surfaces, place absorbent pads in strategic locations, monitor on a regular basis for recurring deficiency, and perform appropriate maintenance service in a timely manner if active fluid leaks are discovered. Consult a qualified technician or reputable service facility to discuss troubleshooting & service options.

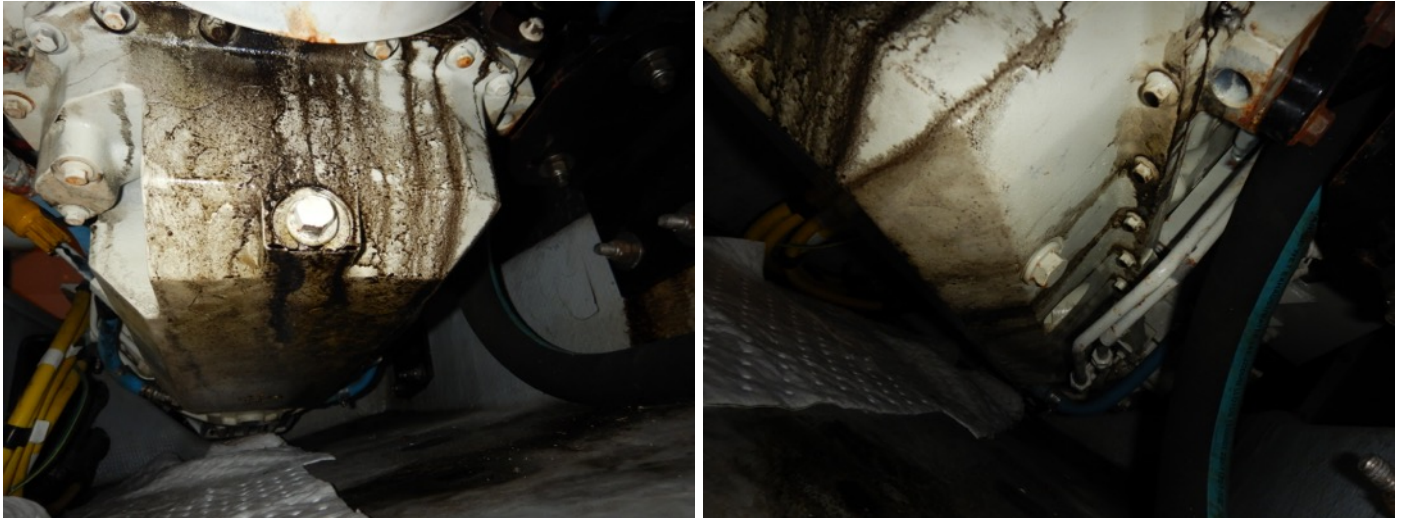
17. PORT Engine Oil Leak

There was evidence of an excessive oil leak identified in the engine room bilge compartment area underneath the PORT engine. The oil leaks appeared to originate along the oil pan gasket & possibly the front crank shaft seal. Recommend appropriate PORT engine maintenance service be performed with the intent to eliminate or reduce the severity of oil leaks. Consult a qualified technician or reputable service facility to discuss troubleshooting & service options. Clean & dry bilge compartment surfaces, place absorbent pads in strategic locations, monitor on a regular basis for recurring deficiency, and perform appropriate maintenance service in a timely manner if active fluid leaks are discovered.
