REPORT OF MARINE SURVEY

CONDITION & VALUATION

■■■■■ MERIDIAN 341 SEDAN

Cale Mathers – ■■■■■
SAMS® Accredited Marine Surveyor®

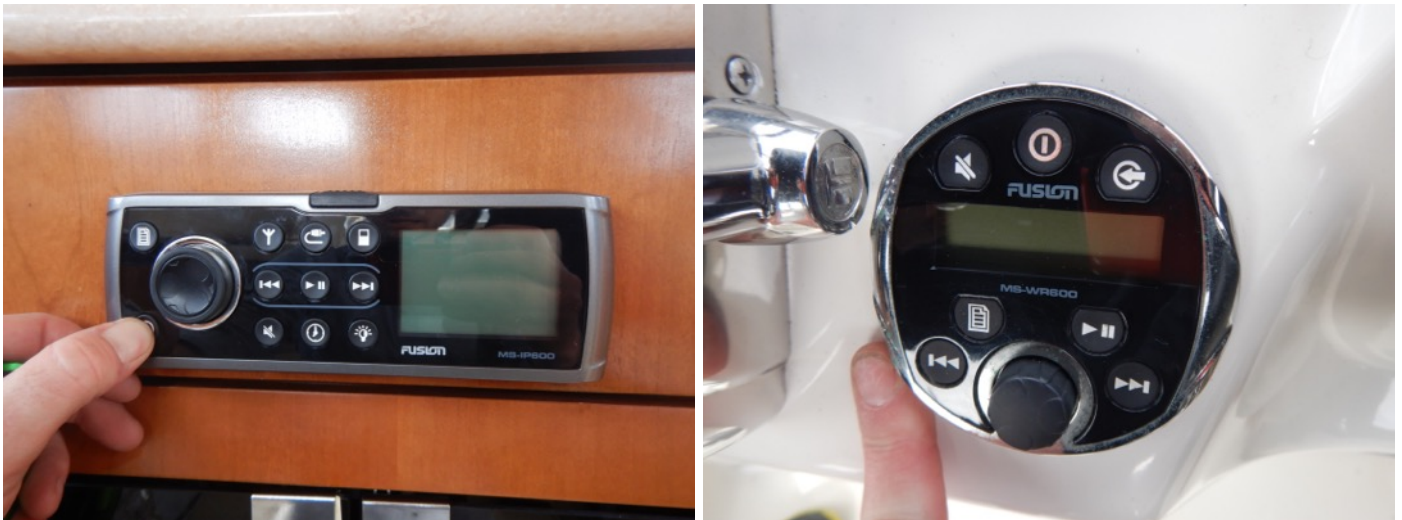
18. Stereo

The FUSION stereo system was INOPERABLE. The stereo control units would not power on during testing procedures. Further investigation is needed to determine an explanation for the deficiency described. Recommend adjust, repair, or replace defective stereo system components as needed with the intent to improve operating performance.

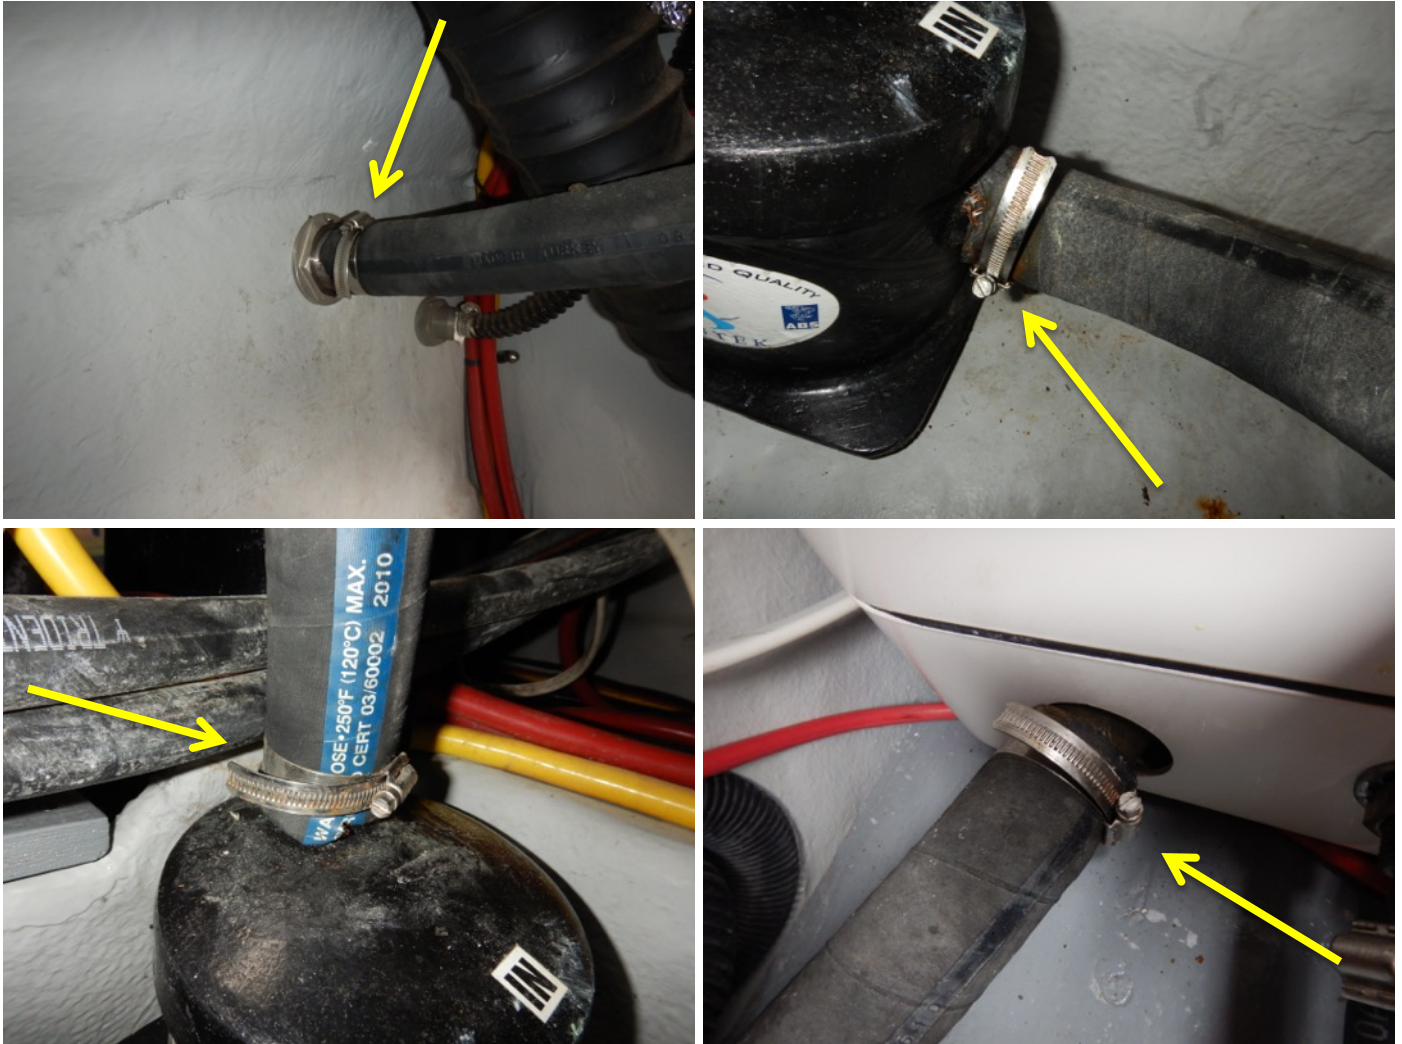
19. Generator Exhaust Hose Connections

Generator engine exhaust hoses were secured at each connection point using a single hose clamp fastener. ABYC recommends: *Every exhaust hose connection shall be secured with at least two non-overlapping clamps at each end to produce a secure, liquid and vapor tight joint (ABYC P-1.7.1.10.1).* Recommend additional stainless steel hose clamp fasteners be installed at generator engine exhaust hose connections with the intent to comply with ABYC recommendations.

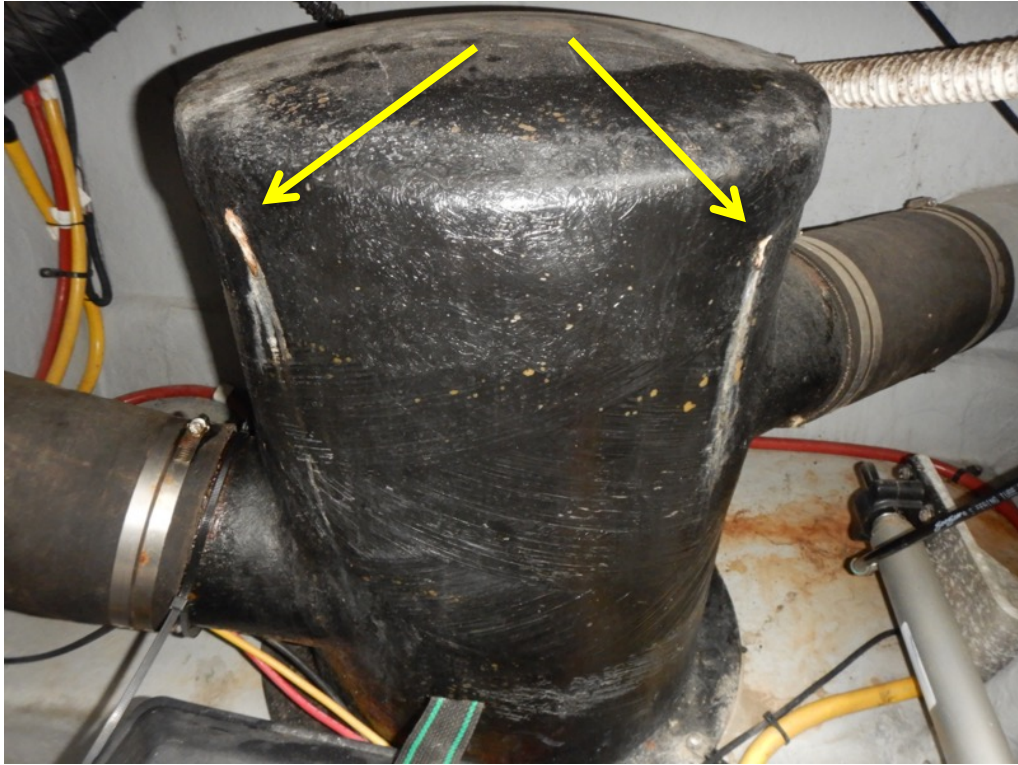
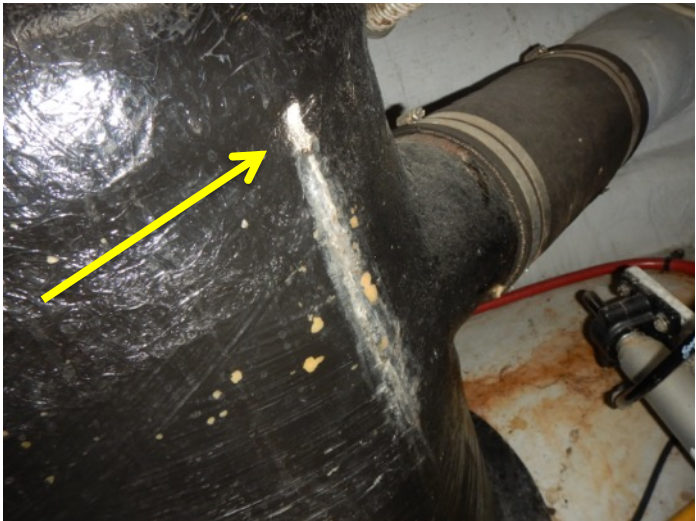
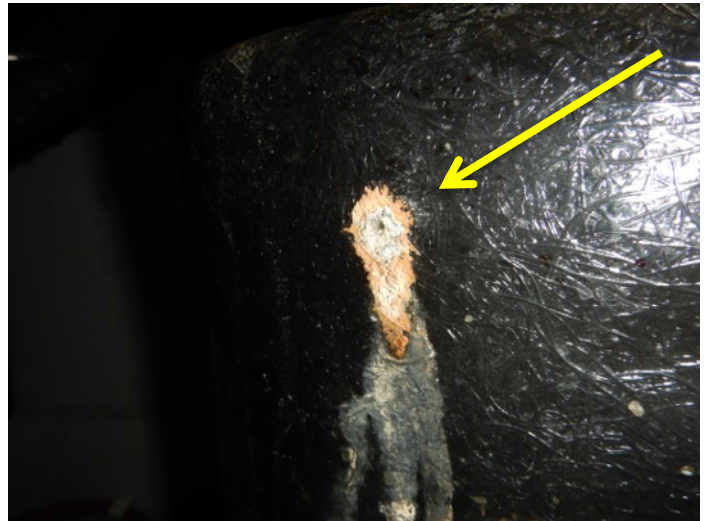
20. STBD Engine Waterlift Muffler

There was evidence of water leaks identified in two separate locations at the waterlift muffler device serving the STBD engine's wet exhaust system. Water leaks appeared to originate at small holes in the fiberglass muffler. Recommend appropriate fiberglass waterlift muffler repairs be performed with the intent to eliminate wet exhaust system water leaks. Consult a qualified technician or reputable service facility to discuss troubleshooting & service options.

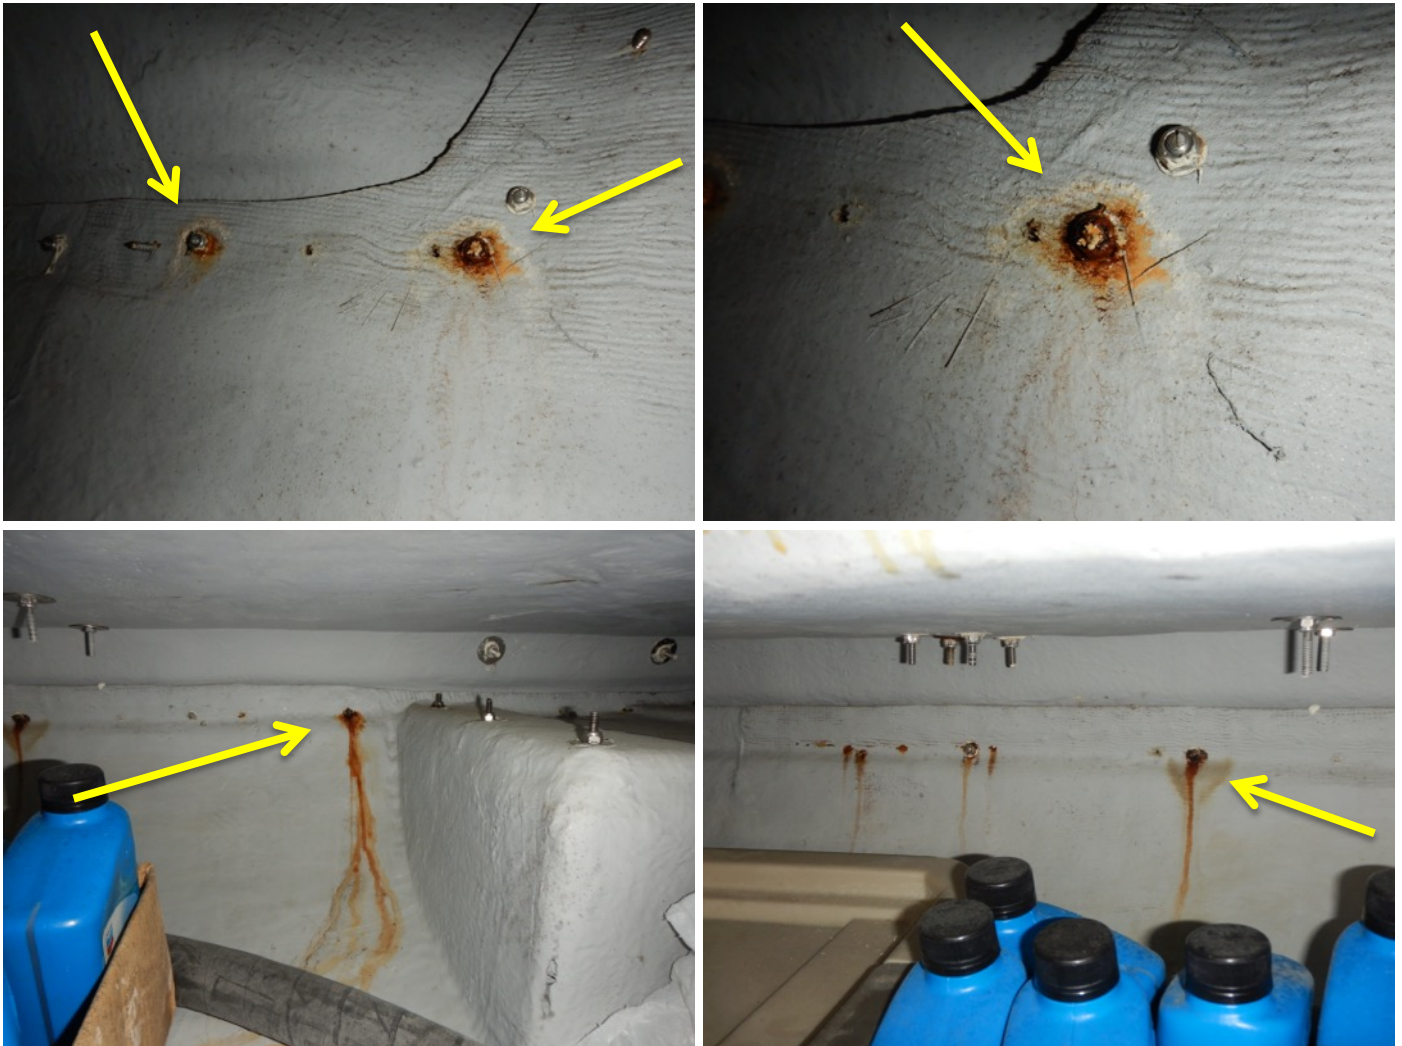
21. Hull-to-Deck Joint Water Leaks

There was evidence of mild water leaks identified in the lazarette bilge compartment. The leaks appeared to originate at hull-to-deck joint fasteners installed around the perimeter of the swim platform portion of the hull structure. The orange water leak stain markings are usually an indication that the fasteners are suffering from the effects of crevice corrosion. Recommend clean & dry bilge compartment surfaces, monitor on a regular basis for recurring deficiency, and perform appropriate hull-to-deck joint repairs during the vessel's next out-of-water service as an act of preventative maintenance. Leaking fasteners should be removed & replaced with marine grade stainless steel fasteners that are installed using marine adhesive sealant.

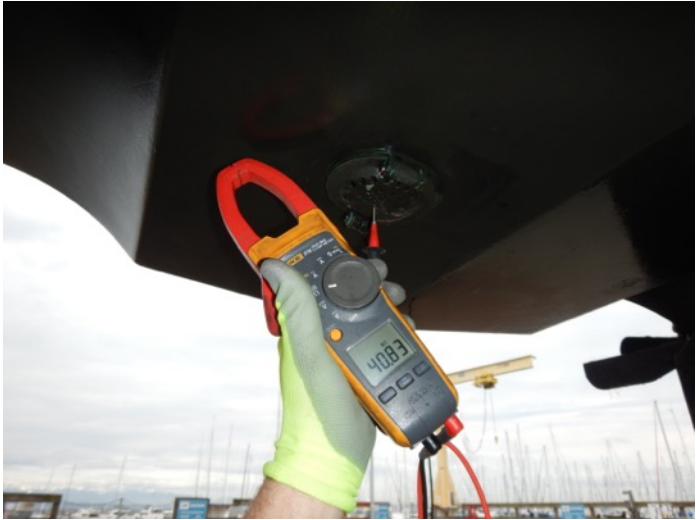
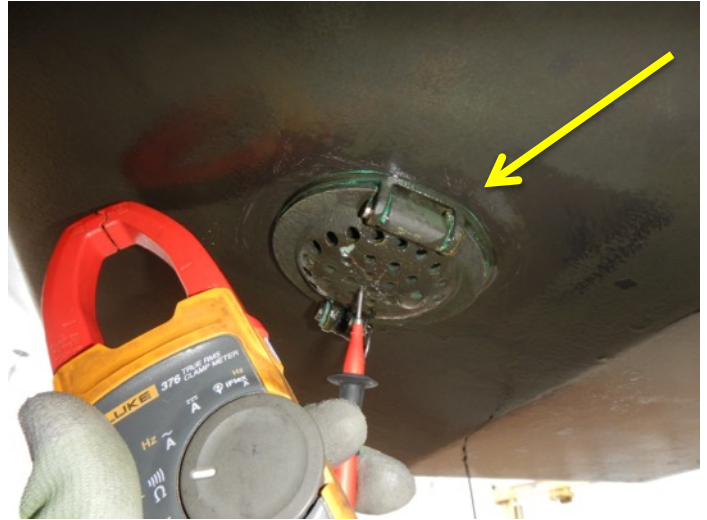
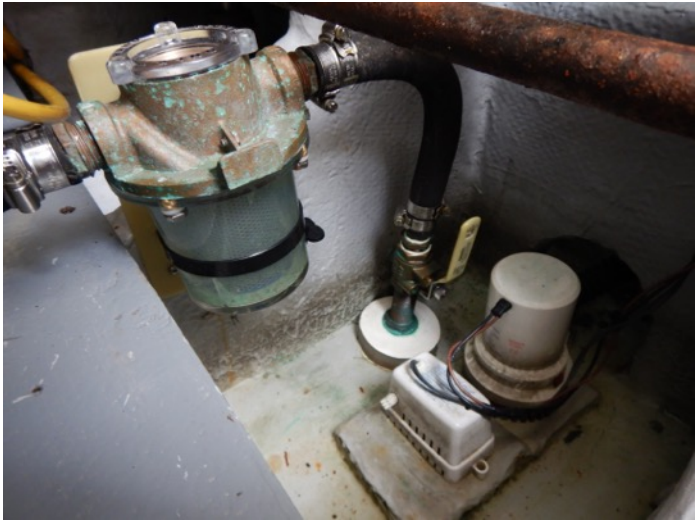
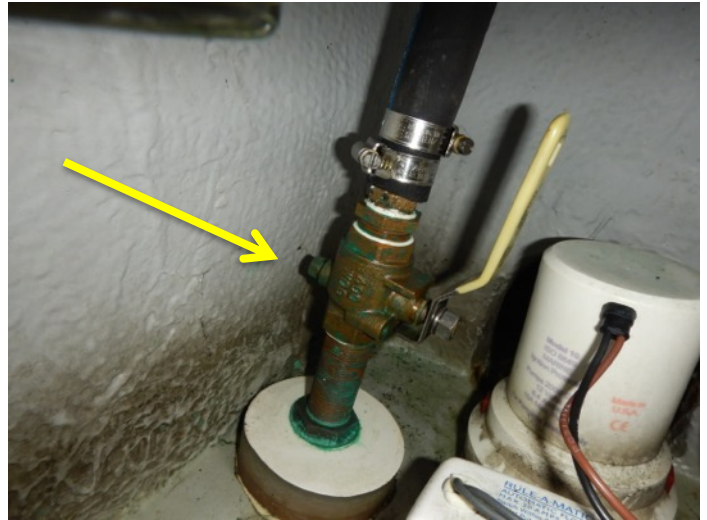
22. Generator Engine Thru-Hull & Seacock Valve

There was evidence of mild corrosion damage identified at the below-the-waterline bronze thru-hull fitting used to supply seawater to the generator engine. The thru-hull fitting described was not connected to the vessel's bonding system. Recommend the generator engine seacock valve be terminated to the bonding system for the purpose of providing cathodic protection for corrosion prevention purposes.

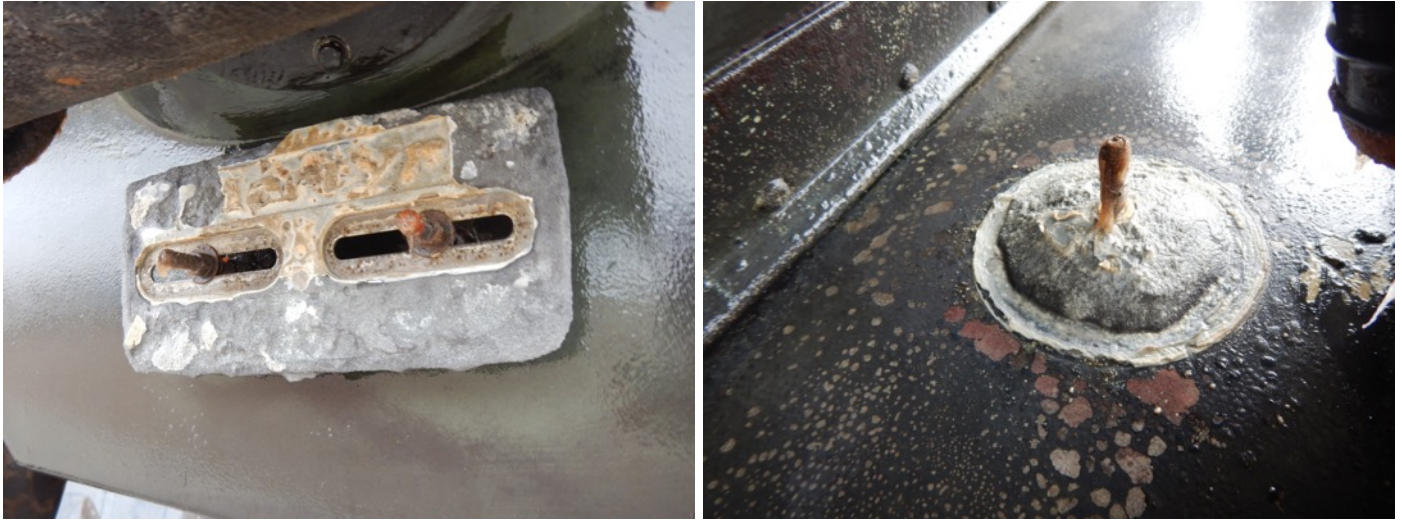
23. Sacrificial Anodes

The sacrificial anodes appeared in BELOW AVERAGE condition when observed during the out-of-water portion of the inspection. The anodes appeared to be nearing the end of their useful service lives. Recommend the sacrificial anodes be replaced as an act of preventative maintenance.
